Water Quality Annual Report

2017/18

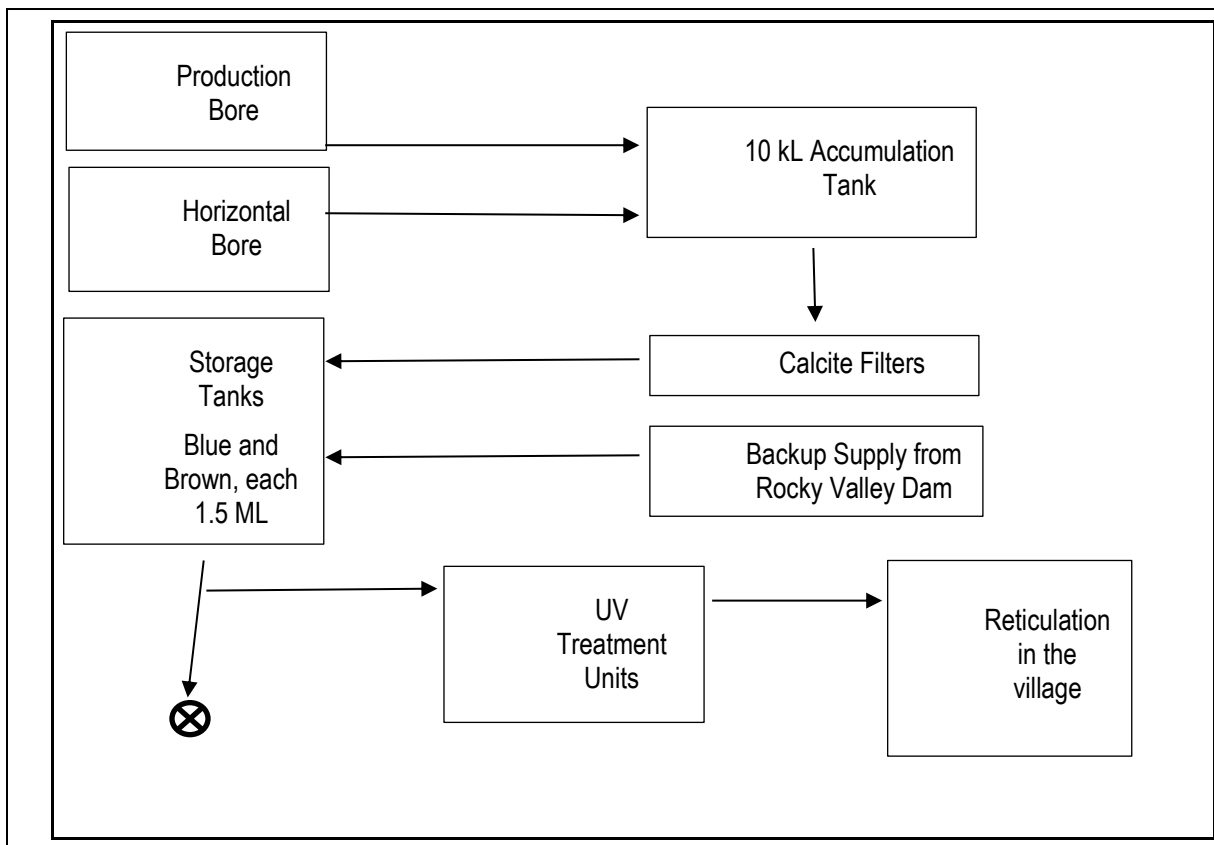
Figure 2 Schematic Diagram of Bore, Horizontal Drains, Accumulation Tank, Calcite Filter, Header Tanks, UV system and UV By-pass.

- New storage facility inlet works provided the capacity for FCARMB to fill the storage tanks (Brown and Blue) either from the groundwater source or from surface water in Rocky Valley Dam;
- A new UV Treatment System was introduced which replaced the old technology UV with two "state of the art" UV units. The two new UV water treatment units operate simultaneously. The automation system controls the operation and monitors the status of the water UV treatment units.

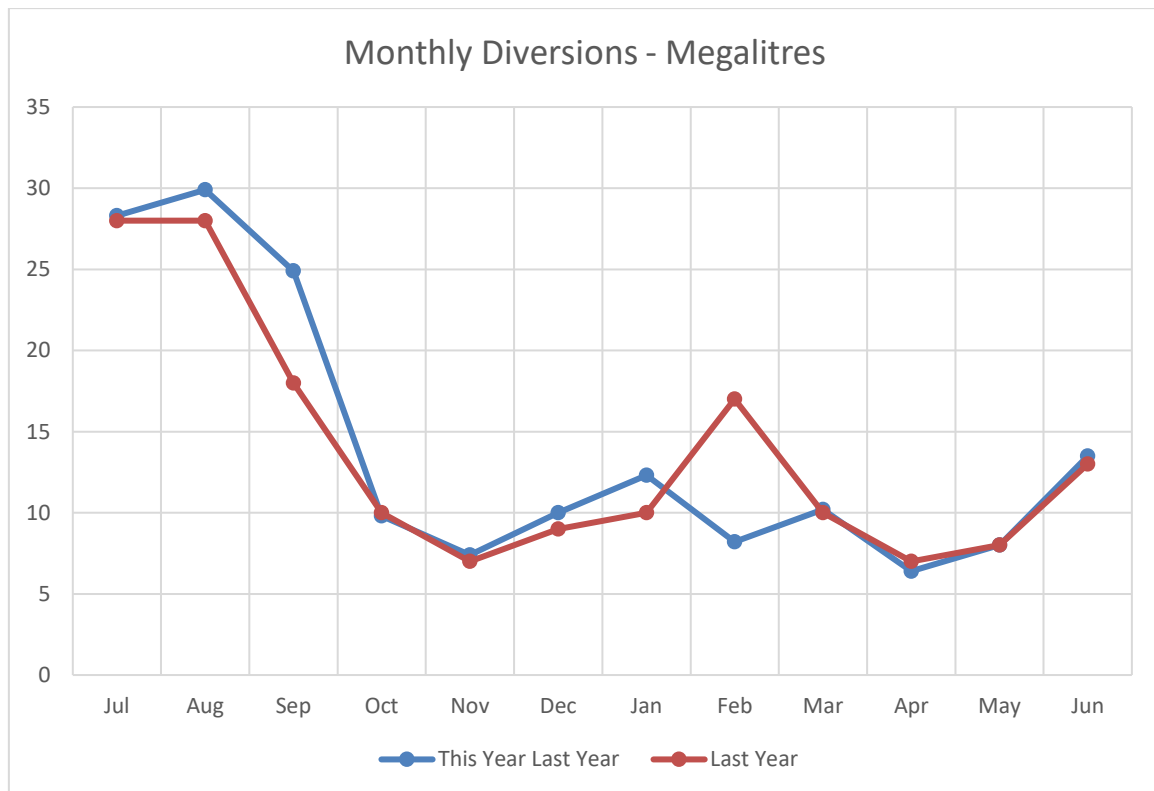
The winter seasonal nature of highest consumptive use is demonstrated in the following graph of monthly diversions.

Year	Volume Diverted (ML)
2017-18	169
2016-17	167
2015-16	162
2014-15	147
