Water Quality Annual Report

2019/20

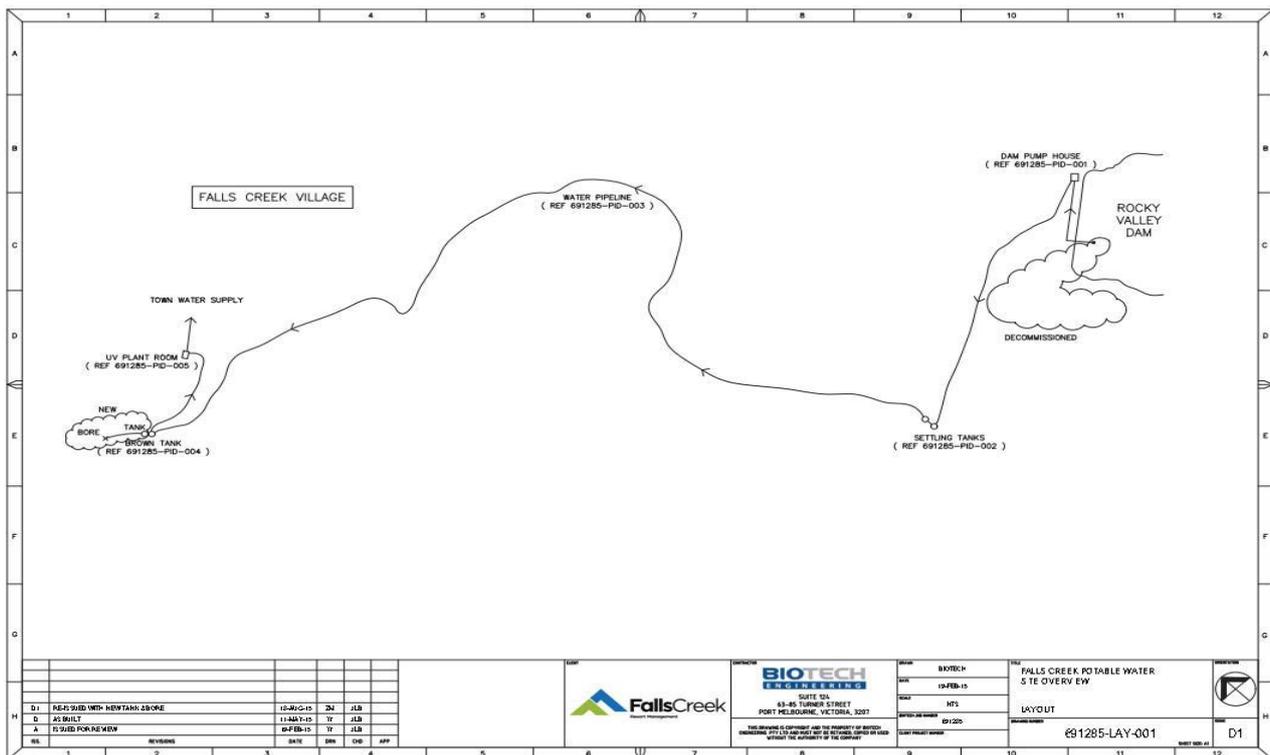
Figure 1 - Diagram of supply system

- An intake within the Rocky Valley Dam;
- A pumping station, that transferred water from the Dam to two Settling Tanks;
- Two Settling Tanks, which provided a means to allow any residual suspended solids to be removed
- A pipeline/gravity main to Blue and Brown storage tanks

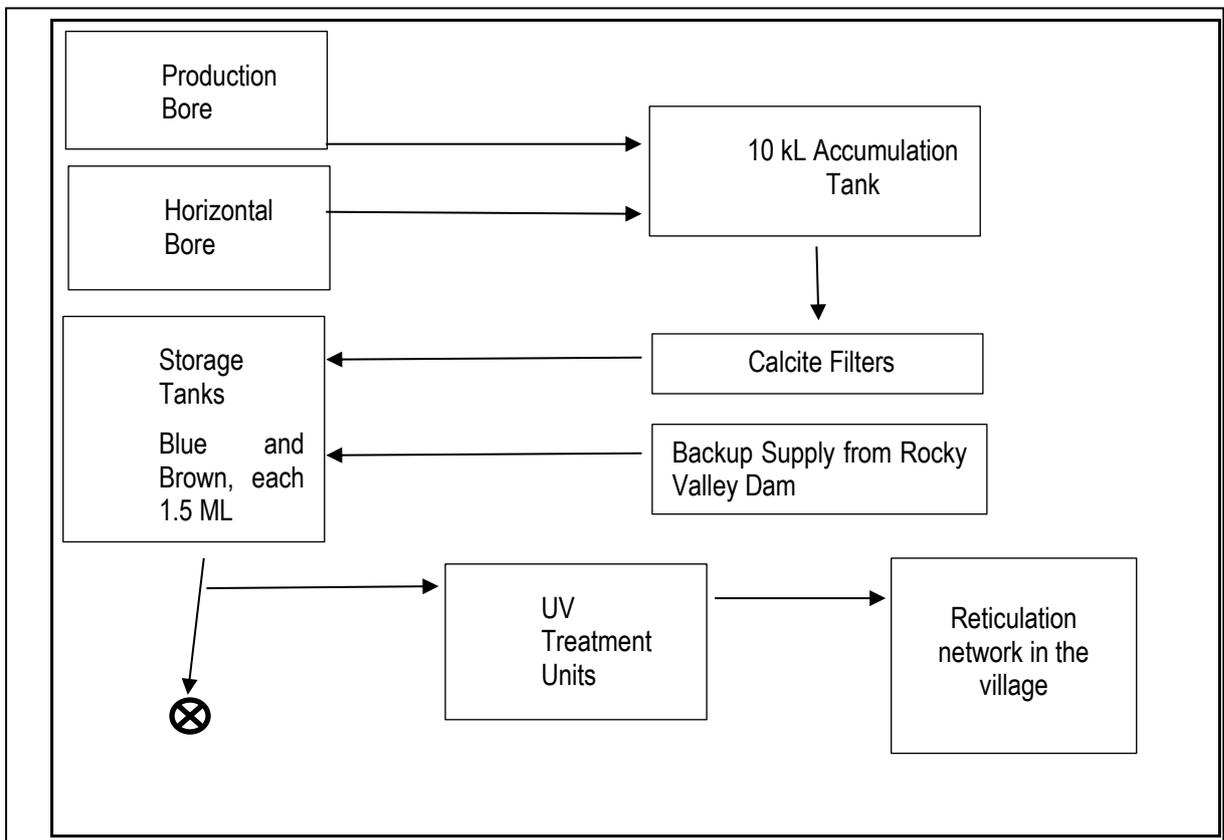
Figure 2 Schematic Diagram of Bore, Horizontal Drains, Accumulation Tank, Calcite Filter, Header Tanks, UV system and UV By-pass.

A Horizontal Bore is also linked to the Drinking Water Supply. This bore is part of a system of bores that were constructed to facilitate hydrostatic depressurisation of geological features in the vicinity of the Falls Creek village.

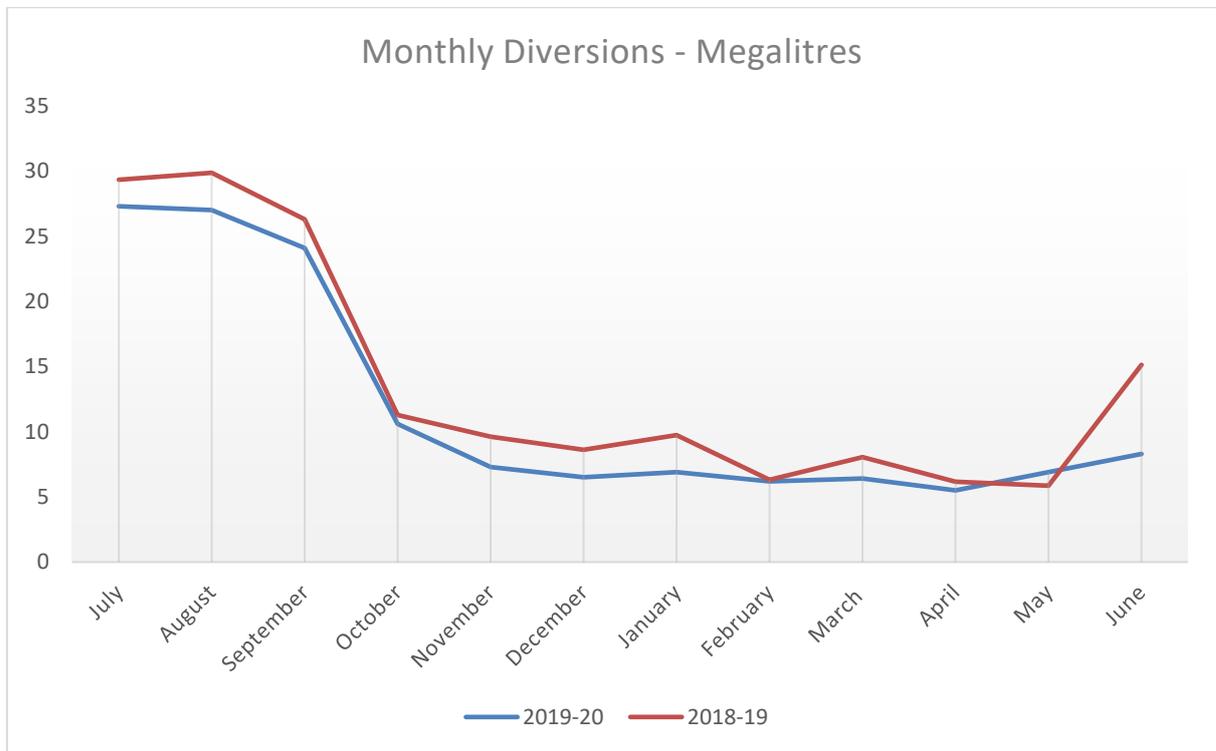
The winter seasonal nature of highest consumptive use is demonstrated in the following graph of monthly diversions. The average water consumption for the past three reporting periods was 167ML a year. The water consumption for the 2019-20 reporting period is 143ML. The drop in

demand is associated with the 2019-20 bushfires and the COVID-19 pandemic. These two events had dramatically reduced visitation to the resort.
